# **PART 1 BACKGROUND, CONCEPTUAL FRAMEWORK AND METHODS**

## **1.1 Introduction and context**

The December 2004 Cut off Low triggered widespread flooding and rain damage across the Western Cape, specifically affecting the Overberg, Cape Winelands, Central Karoo and Eden District Municipalities. The extreme weather and subsequent flooding had severe direct and indirect impacts to local municipal infrastructure, the agricultural sector and vulnerable communities, such as households adjacent to riverine environments, low income housing and informal settlements.

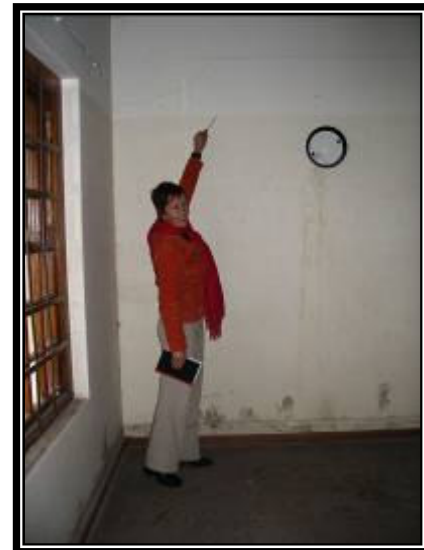
**Fig 5:** The flood line inside a house on the banks of the Duiwenhoks River, Heidelberg, May 2005.

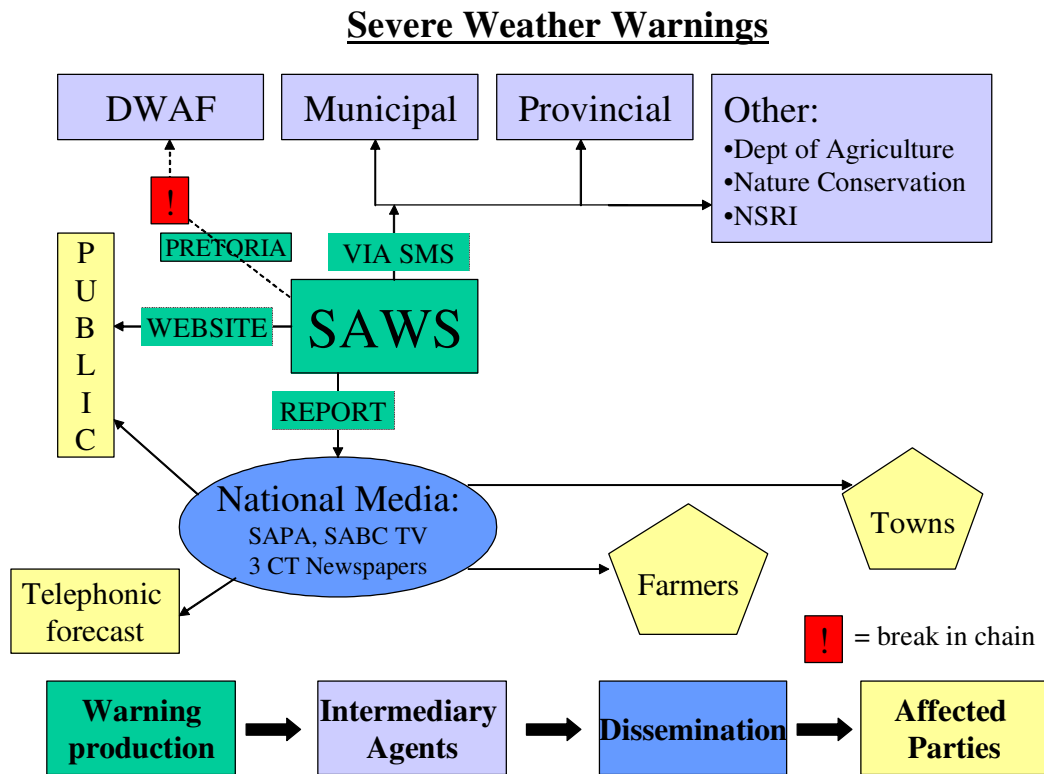
Disaster Managers receiving the SMS warnings are expected to relay the warning message downward to role players in their specific areas on a need to know basis. At a municipal level however several officials reported never receiving either the weather advisory or the severe weather warning. The SAWS explained that this may in part be due to the initial 'list of individuals to contact' being incomplete.

**Fig 6:** Schematic chart summarising the operations of weather warning production and dissemination

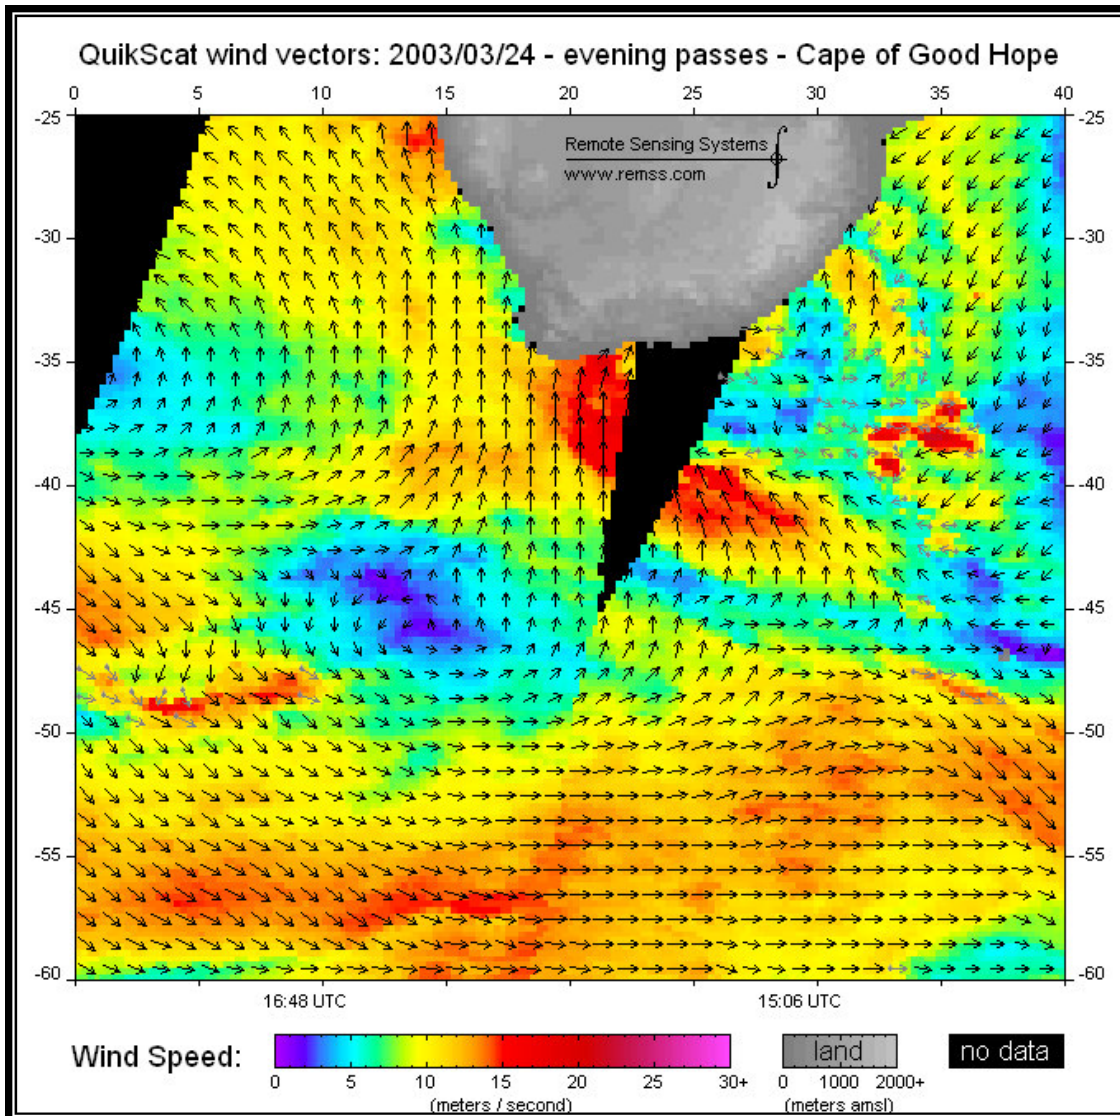
**Fig 7:** Quikscat wind vector image of South Africa during its evening pass of 24<sup>th</sup> March 2003

From the two Quikscat images portrayed above and below, it can be seen that the speed of the jet was considerably higher for the March 2003 event as apposed to that of the December 2004 event. Never the less, both events produced significant amounts of rainfall.

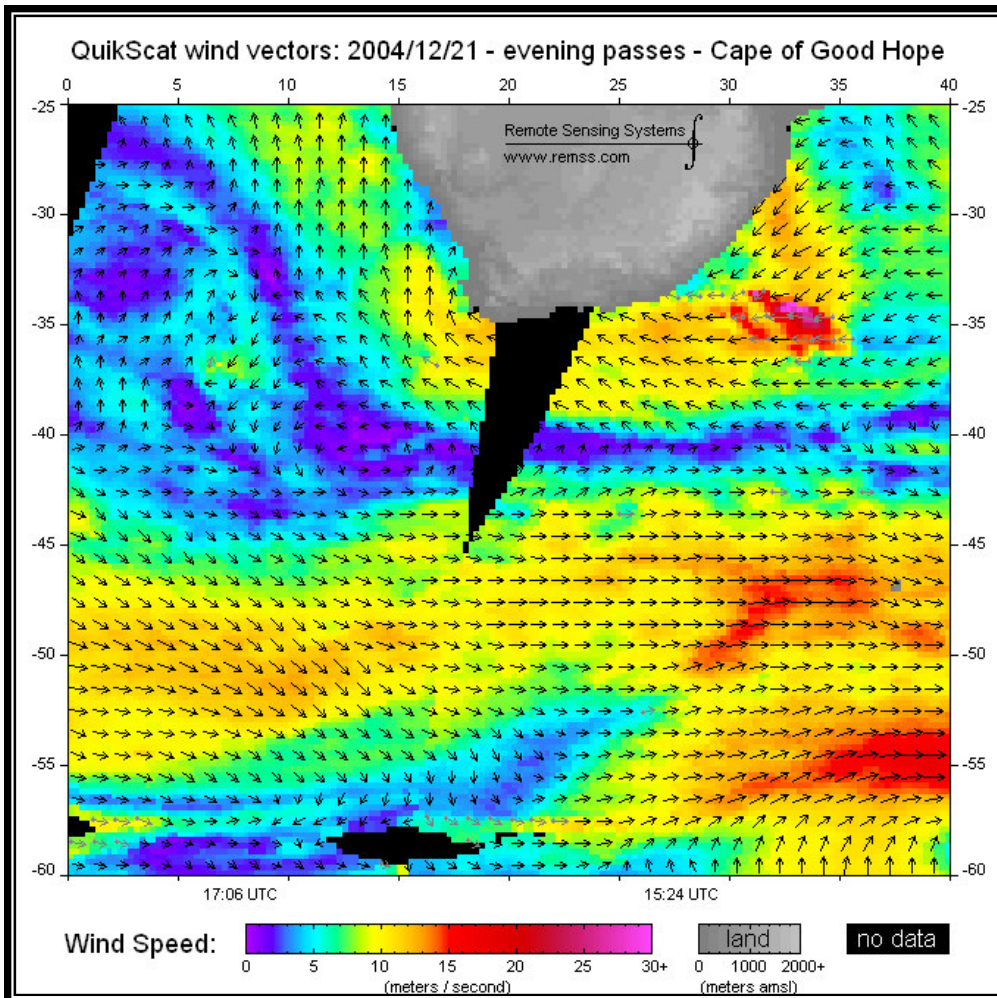
**Fig 8:** Quikscat wind vector image of South Africa during its evening pass of 22<sup>nd</sup> December 2004

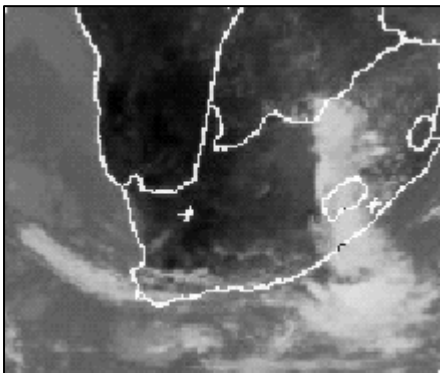
Satellite Infra Red images indicate temperature, white being the coldest and black the warmest. The white on the adjacent image therefore shows clouds which are high and cold and have a high potential for rain. On the day represented here, Heidelberg and George received their highest rainfall for this event, 118.5mm and 99.8mm respectively. The clouds in the satellite image for the 21<sup>st</sup> December are most likely very large cumulonimbus cells which developed in the warm moist and unstable circulation from the north, ahead of the Cut-off Low. There was no

recorded rainfall in Robertson and Swellendam for this day while stations in Riversdale recorded 21.4mm, George 99.8mm and Knysna 15mm.

**Fig 9:** EUMETSAT Infra Red Satellite Image of South Africa 9a.m. on the 21<sup>st</sup> December 2004

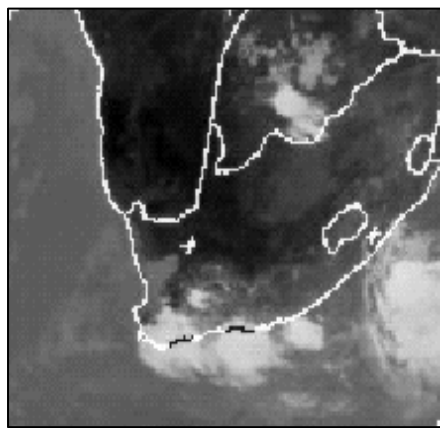
This Infra Red satellite image for the 22<sup>nd</sup> December 2004 shows the clouds formed by the now fully developed cut off low. Rainfall was highest on this day for the areas

under study with the exceptions of Heidelberg and George where highest rainfall was experienced over the first day of this event (21<sup>st</sup> Dec). Recorded rainfall at Robertson was 185mm, Swellendam 97.5mm, Heidelberg 46.5mm, Riversdale 126.6mm, George 57.6mm and Knysna 199.2mm. The cloud cover visible in this image reveals the extent of the area affected by this event.

**Fig 10:** EUMETSAT Infra Red Satellite Image of South Africa 9am on the 22<sup>nd</sup> December 2004

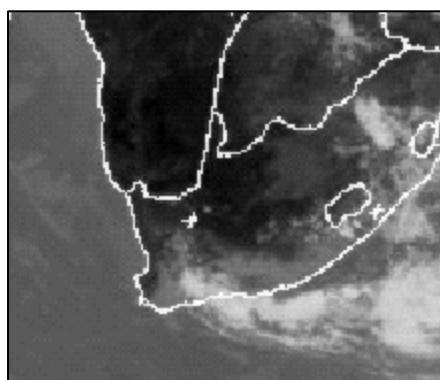
By the 23<sup>rd</sup> December 2004 the cut off low had begun to dissipate. This is seen clearly in the EUMETSAT Infra Red image for this day through the visible breakdown in

structure of the cloud formation. The rainfall over the study area for this day corresponds with the dissipation of the cut off low as stations at Robertson recorded 3.2mm rainfall, Swellendam 0mm, Heidelberg 3mm, Riversdale 19.2mm, George 8mm and Knysna 4.6mm, considerably less than the previous two days.

**Fig 11:** EUMETSAT Infra Red Satellite Image of South Africa 9am on the 23<sup>rd</sup> December 2004

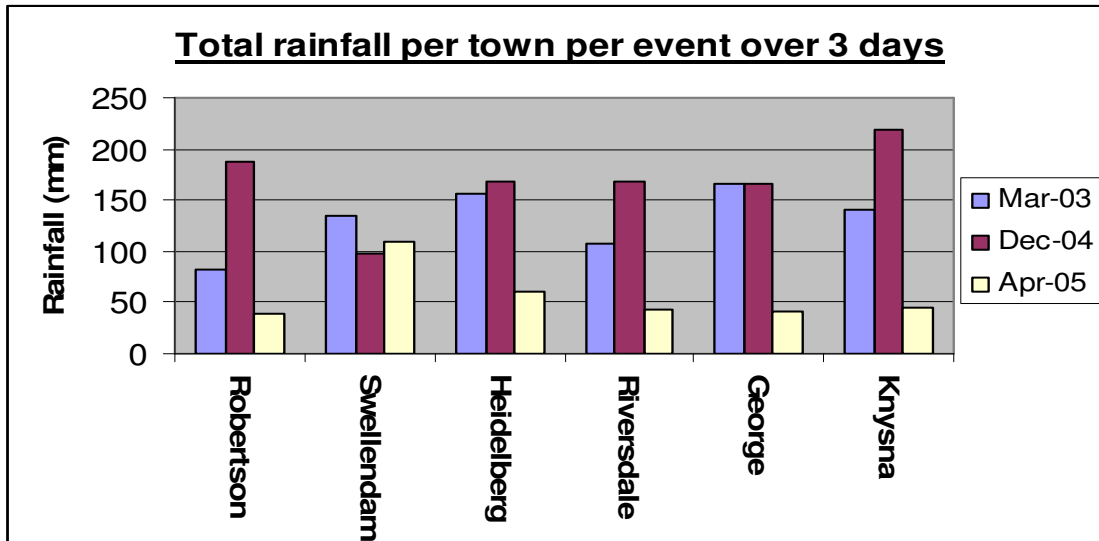
**Fig 12:** Graph comparing rainfall data from the March 2003, December 2004 and April 2005 events

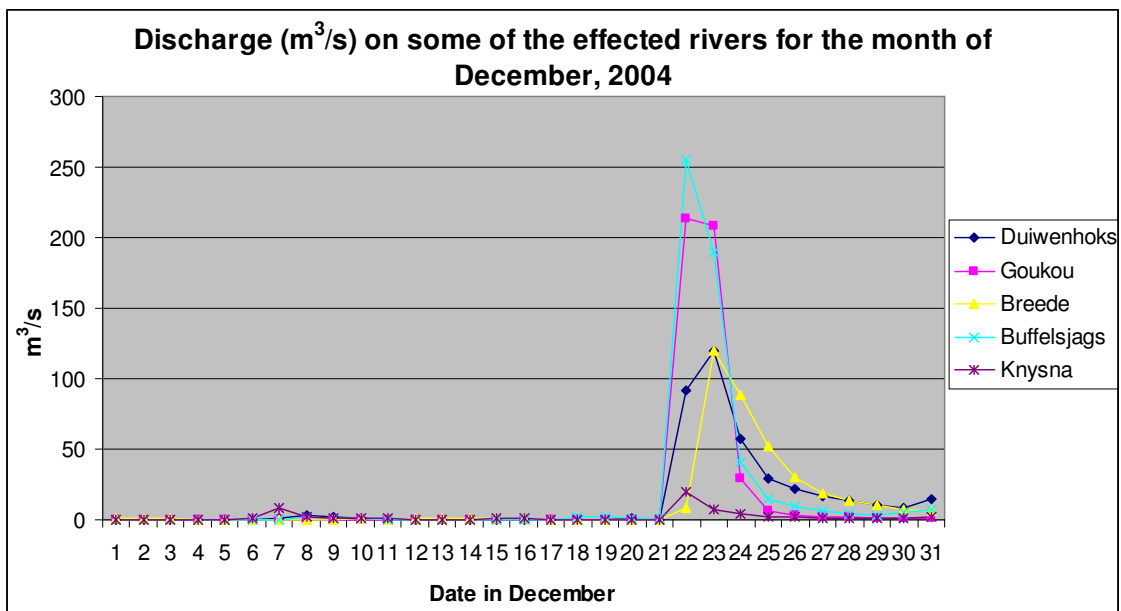
**Fig 13:** Discharge for the month of December on some of the rivers in the affected area. Note how rapidly they rise to over 10 times the normal discharge in just 24

hours, and then return to almost pre-flood levels in just a few days. (Data source: DWAF)

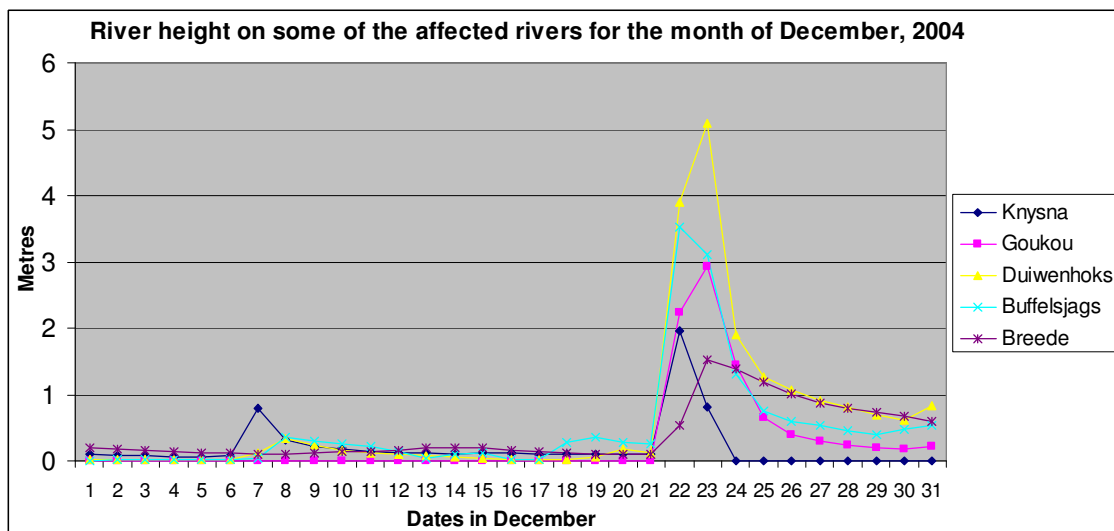
**Fig 14:** River height in metres of the same rivers as shown in figure 13. Note the relatively small rise in river height on some of the rivers around the 6-8 December. This is the rise in river level to be expected from a more usual rain event for this period

of the year. In some cases, like on the Duiwenhoks River, the river height is measured at almost ten times its normal height for the month of December. This is a very significant height difference. (Data source: DWAF)

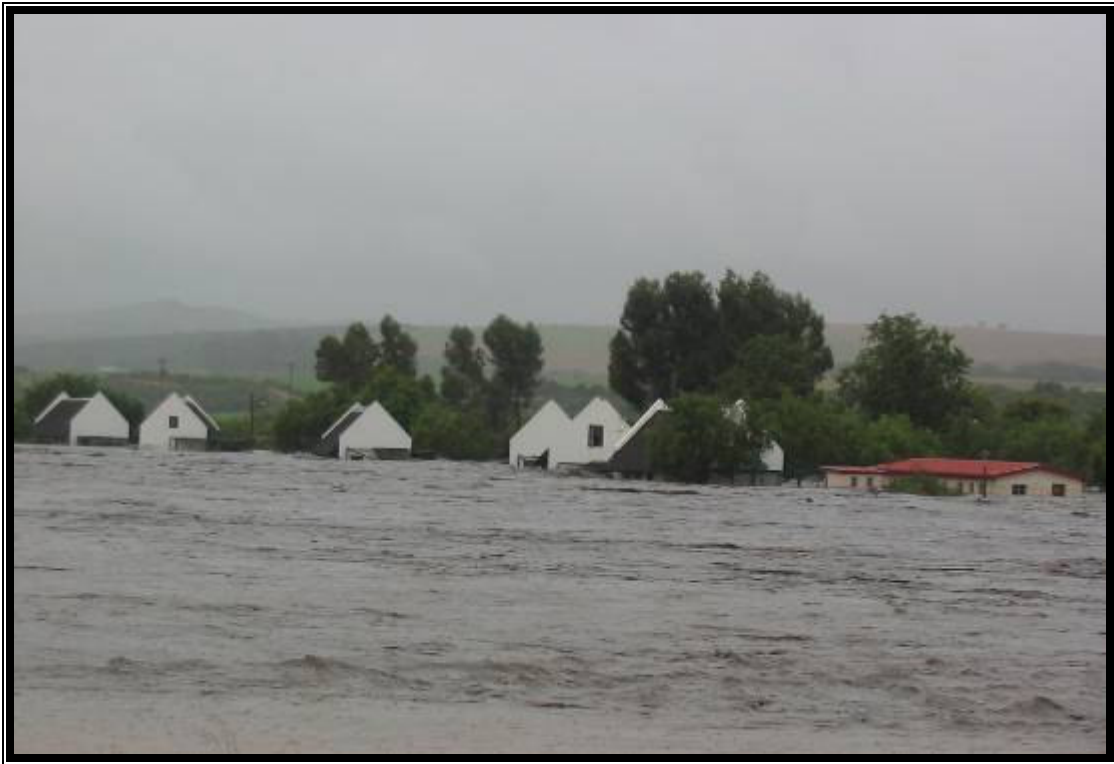
**Fig 15:** The Heidelberg Municipal chalets flooded by the Duiwenhoks River, 22 December 2004.

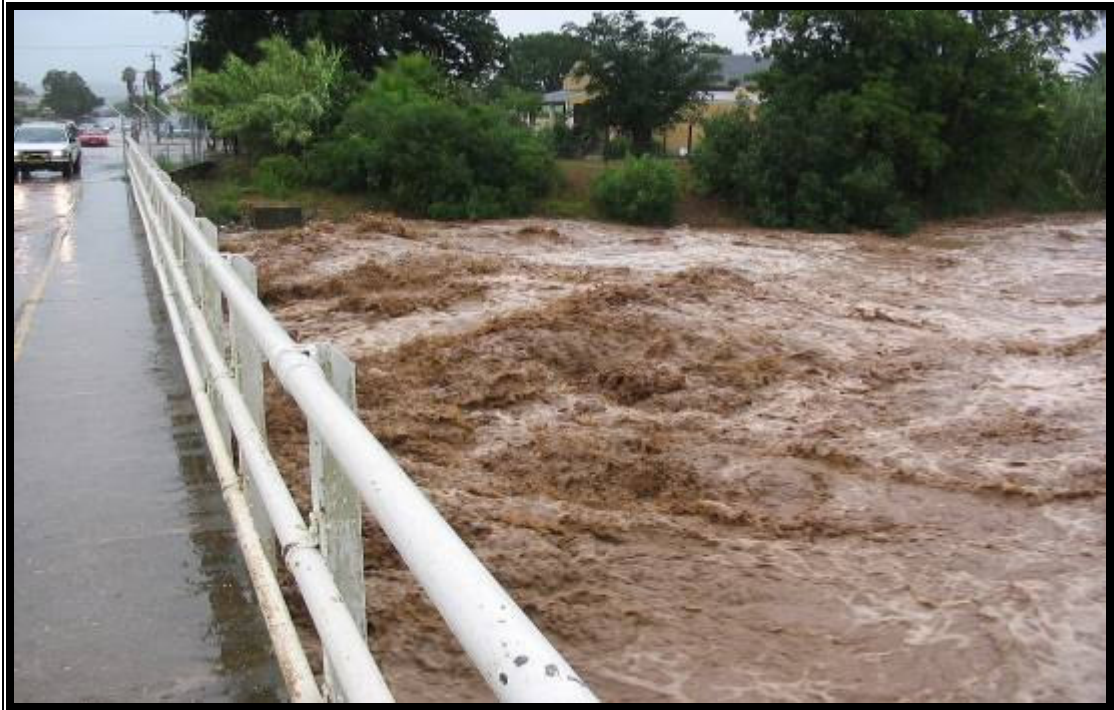
**Fig 16:** Photograph taken on the 22<sup>nd</sup> December 2004 of a bridge in Heidelberg spanning the flooding canal

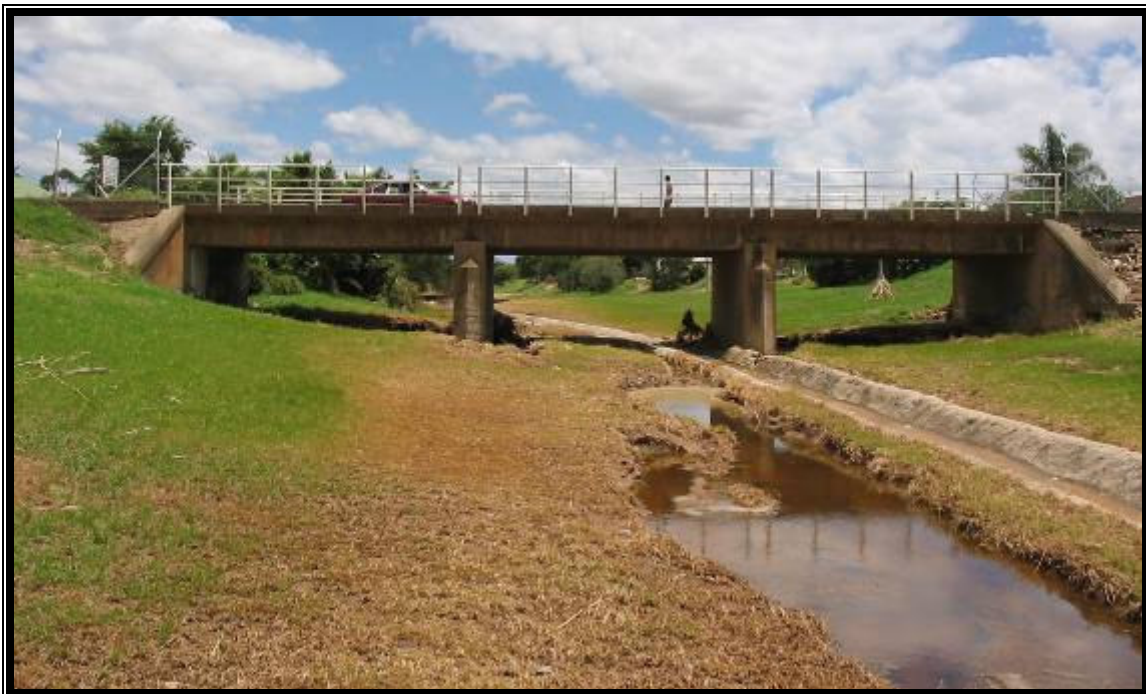
The town of Heidelberg was particularly badly affected in this regard, as 'The Canal', a stream which is canalised through the extent of the town, flooded extensively and as a result, ripped up concrete pathways and damaged bridges and roads (See fig 16). The canalised river flows into the Duiwenhoks River, which was itself flooding extensively (see fig 17), just on the outskirts of the town. In this case, the meeting of

**Fig 17:** The same bridge as in Fig 16 above, photographed on the 28<sup>th</sup> December 2004.

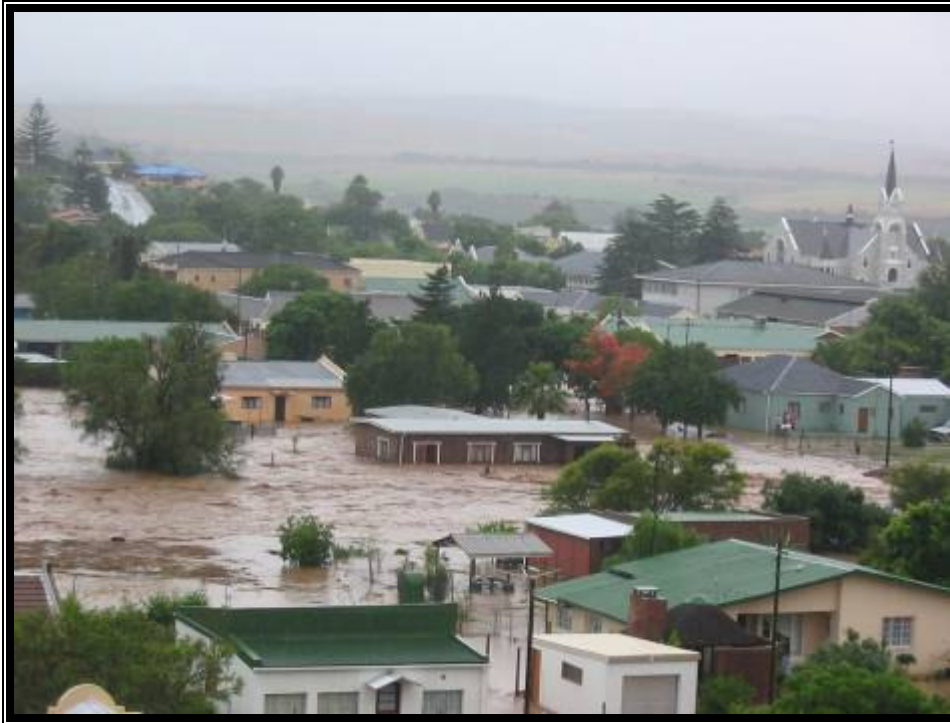
**Fig 18:** Heidelberg on the 22<sup>nd</sup> December 2004

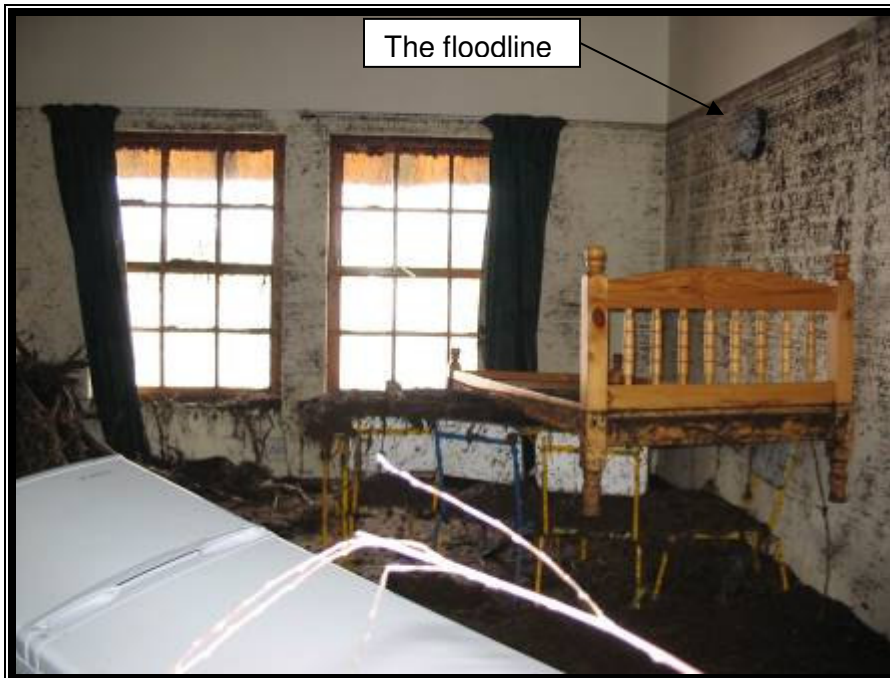
**Fig 19:** The interior of one of the Municipal chalets on the banks of the Duiwenhoks River. Photograph taken on the 23<sup>rd</sup> December 2004.

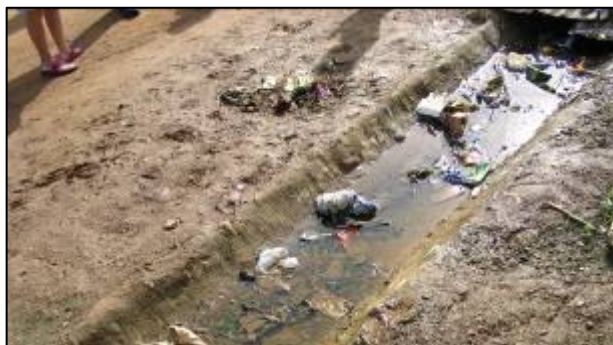
Most of the original dwellings in Suurbraak are situated close to the river. Many new dwellings have however been built in recent years on the hillside above the town as part of a government-subsidised low income housing project. These are laid out in rows perpendicular to the gradient of the hill, separated by dust roads. Lining these roads are small open drains as shown in the photograph below. As is clear from the photograph, these open drains are hardly adequate to deal with normal levels of rain, let alone extreme rainfall. In effect what happens during heavy rainfall is that the drains overflow, flowing over the roads and into the houses, thus creating damp houses at best and flooding houses at worst. This is exacerbated by litter and other blockages in these drains as well as houses that are unplastered and therefore more susceptible to damp.

**Fig 20:** Shallow, debris filled stormwater drain in Suurbraak.

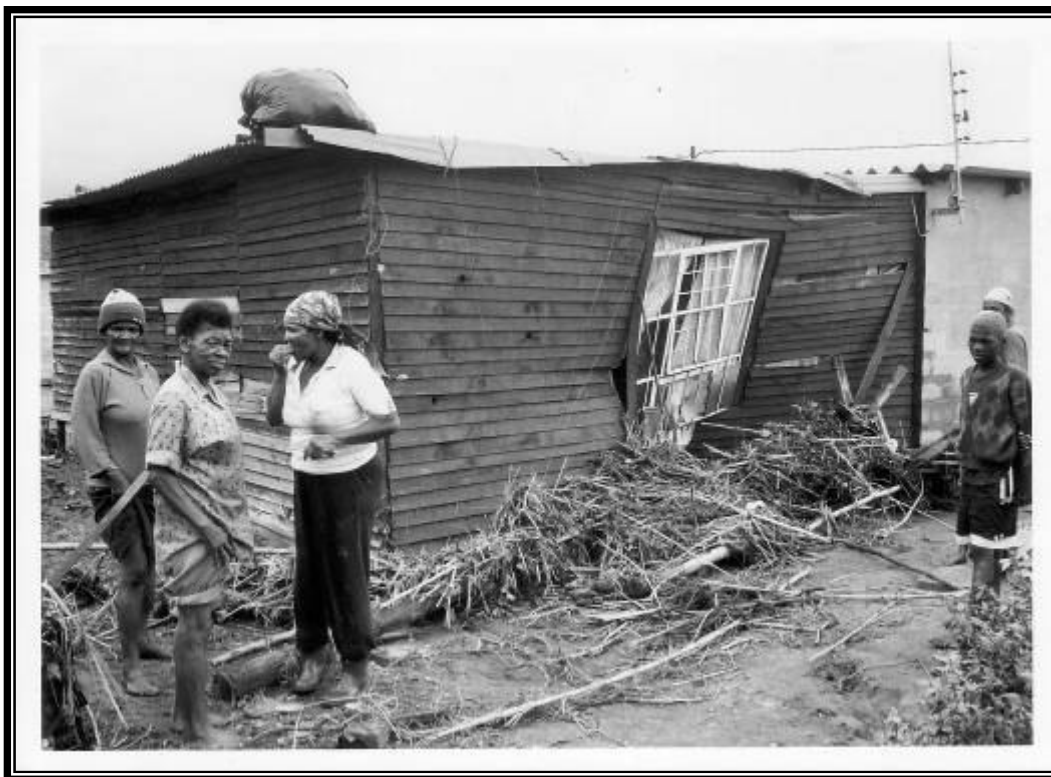
**Fig 21:** Residents of Droëheuwel assessing the damage post the dramatic flooding of the Droë River.

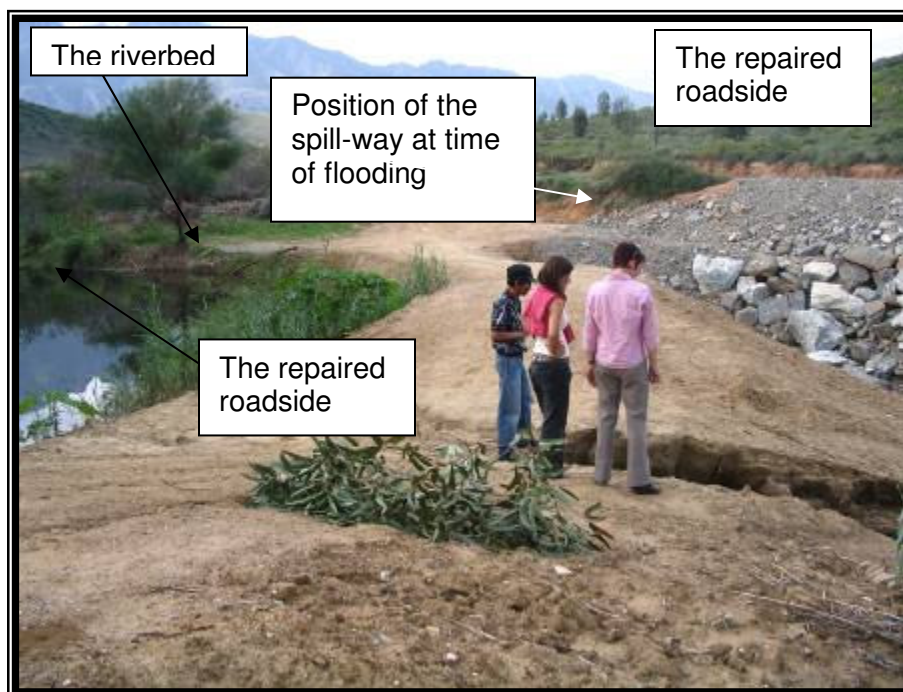
Conflicting accounts of an event further complicate the assessment process. The research team came across some discrepancies in reported accounts of the December 2004 event. An example of such conflicting reports was encountered on meeting with residents and the local councillor of the affected area Droëheuwel. The residents reported that the flood came through their settlement as a wall of water or a large wave. They believe that this anomalous flow was due to the failing of a municipal dam upstream. This was denied by the municipality. On inspection it was noted that extensive repairs had been made to the road opposite the dam such as would have been necessary had a large amount of water passed through a relatively small area, for instance an eroded spill-way. The research team however, lacked the expertise to verify or disprove the theory that the wall of water was indeed caused by a failed dam. It was conveyed that after the flood a person from DWAF had been there to assess the dam wall. This has not been verified.

**Fig 22:** The municipal dam wall on the Droë River alleged to have burst.

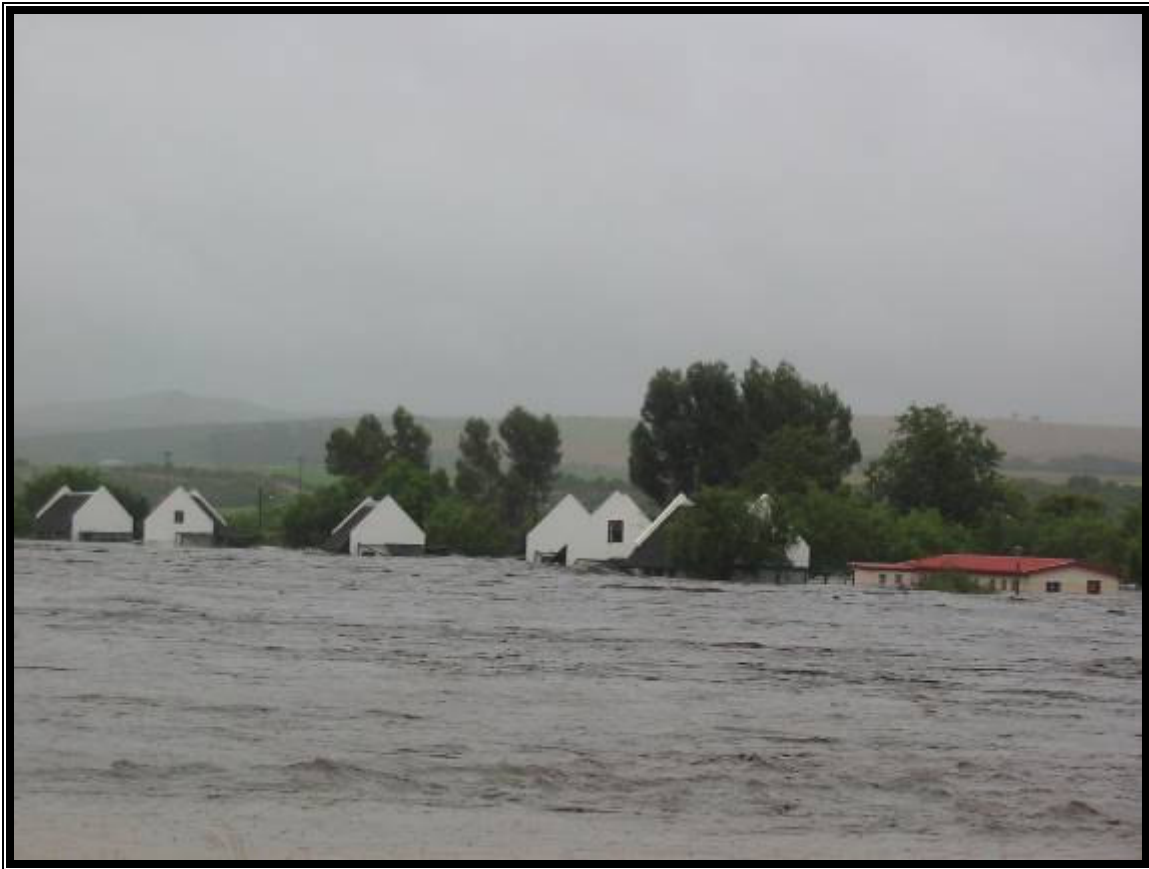
**Fig 23:** The Duiwenhoks River flooding the chalets in the Heidelberg Municipal Holiday Resort on the 22<sup>nd</sup> December 2004.

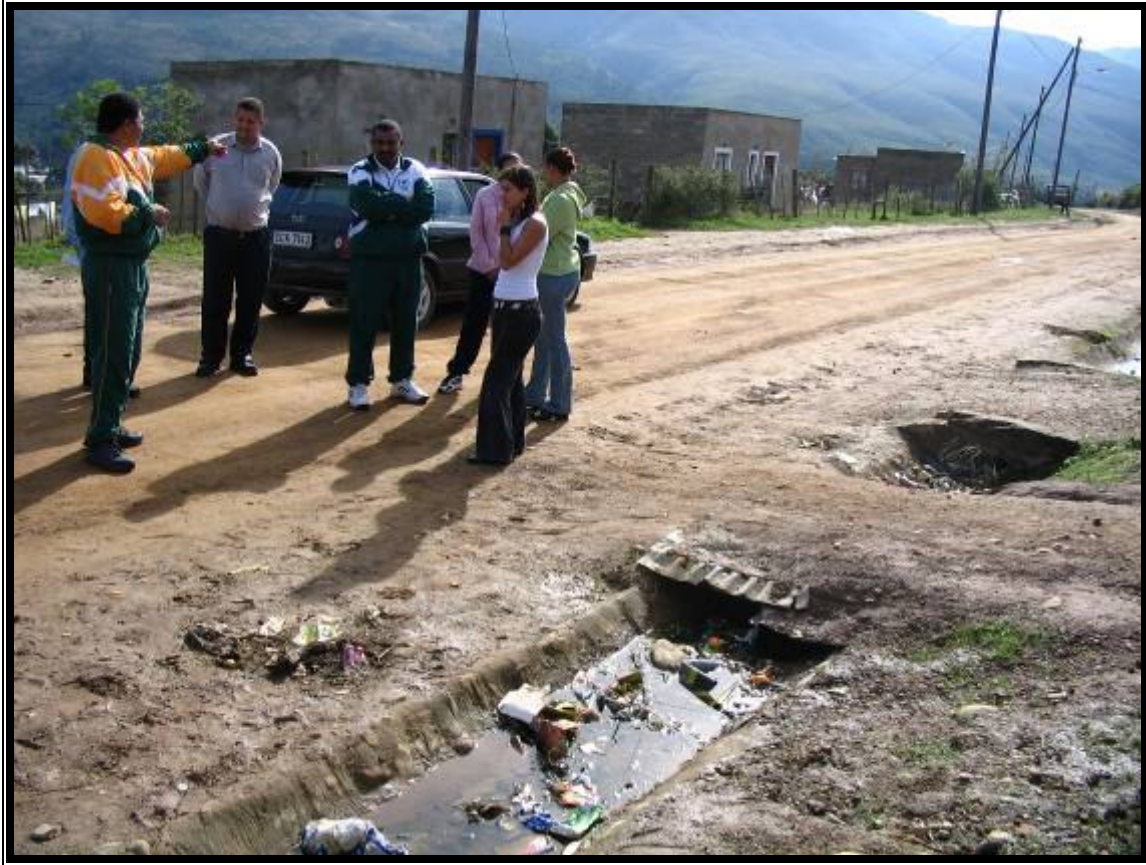
In Suurbraak, some of the homeowners used the money they got from the March 2003 flood payouts to retrofit their houses and thus reduce their risk to flooding and rain damage. However, not all homeowners did this, particularly not those who rent out their houses. The homeowners therefore effectively gained the same amount of rent without reducing the risk of their tenants to flooding and rain through investing in the structural improvement of the dwelling. In some instances households may be damp for as long as six weeks after a heavy rain event, thus causing secondary impacts such as health related impacts.

**Fig 24:** This picture of the low income settlement in Suurbraak shows the shallow open storm water drainage system. As well as being of an inadequate size to deal with the amount of rain typically experienced in this area, as is illustrated, these drains become blocked by litter and other debris,. This area is situated on a slope, so when the drains overflow, the water runs across the road and into the houses.

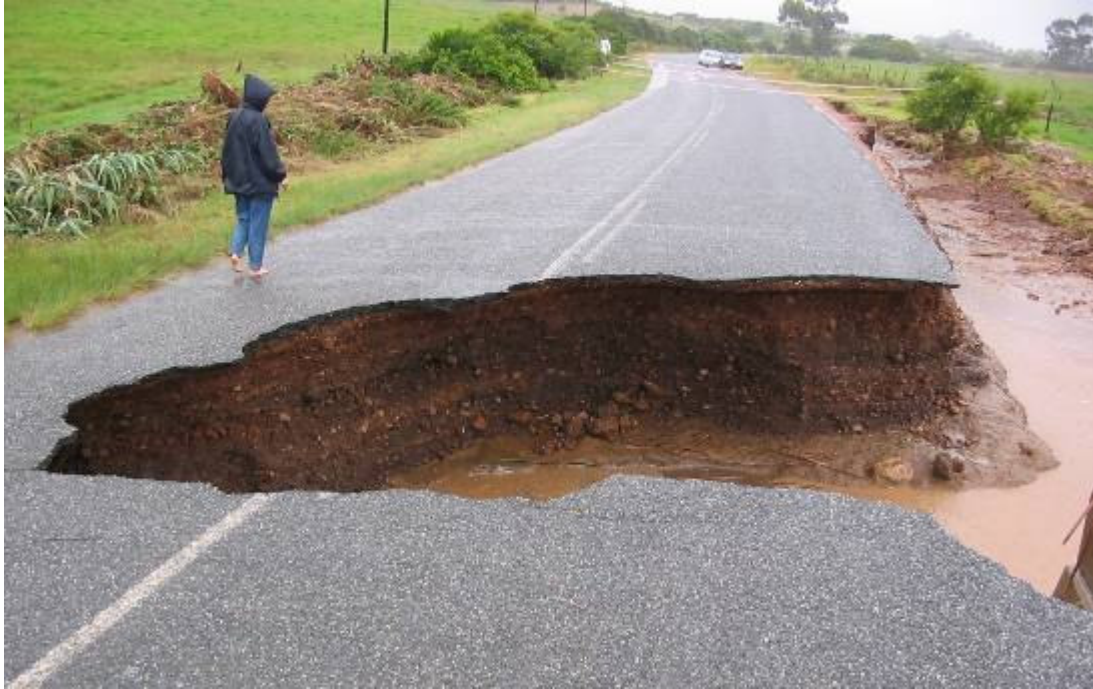
**Fig 25:** Damaged road near Heidelberg, Eden District.

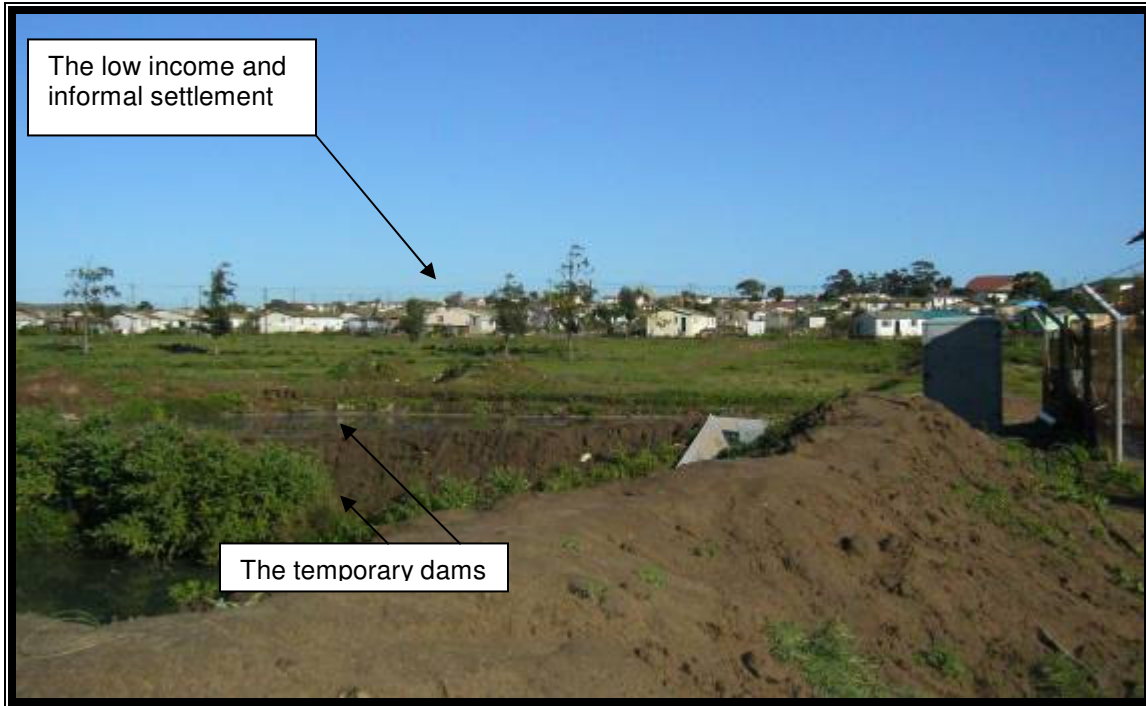
This repeated flooding of the sewage works and subsequent effluent pollution of the Duiwenhoks River lends itself to further examination. Pivotal to the vulnerability of this infrastructure is its placement on the 1:50 year flood plain. In addition to this, it is situated on the opposite bank of the river to the town, which means that all the sewage has to be transported over the river via a pipeline. This pipeline is the first vulnerable point in the sewerage infrastructure to be damaged in a flood situation. Due to the nature of the placement of the sewage works, and the lack of a high water bridge to access the plant, repair workers have to wait for the water to subside before any repair work can be started. This magnifies the pollution impact on a temporal scale as it translates into days on end of raw sewage flowing down the river. Once repair workers could access the works, two unlined dams were dug on the opposite river bank to the flooded sewage works to act as temporary sewage dams until such time as the proper sewerage works were repaired. This raw sewage is discharged directly into the Duiwenhoks River via an open channel cut across the flood plain. There is no fencing around these dams or the channel. This poses both a health as well as a safety risk as there is a low income and informal settlement overlooking this flood plain and the children from this settlement play on this plain right next to the dams and channel. When the site was visited in June 2005, the sewerage works were nearing completion, but the dams were still unfenced and in use (See fig 26 below.)

**Fig 26:** The temporary sewage dams. Photo taken in June 2005.

A quotation was received for both repair work to the sewage works in situ and for relocating of the sewage works to a more appropriate site higher up and on the town side of the river. Due to a lack of funds, it was decided to repair the sewage works in situ and not move it. Both the flood of March 2003 and December 2004 were not classified a disaster in this area (Eden District), with the result that no money was allocated from National Government for post-flood repairs etcetera, this meant that the Municipalities, Districts and Province have had to fund repairs themselves and through the Municipal Infrastructural Grant (MIG).

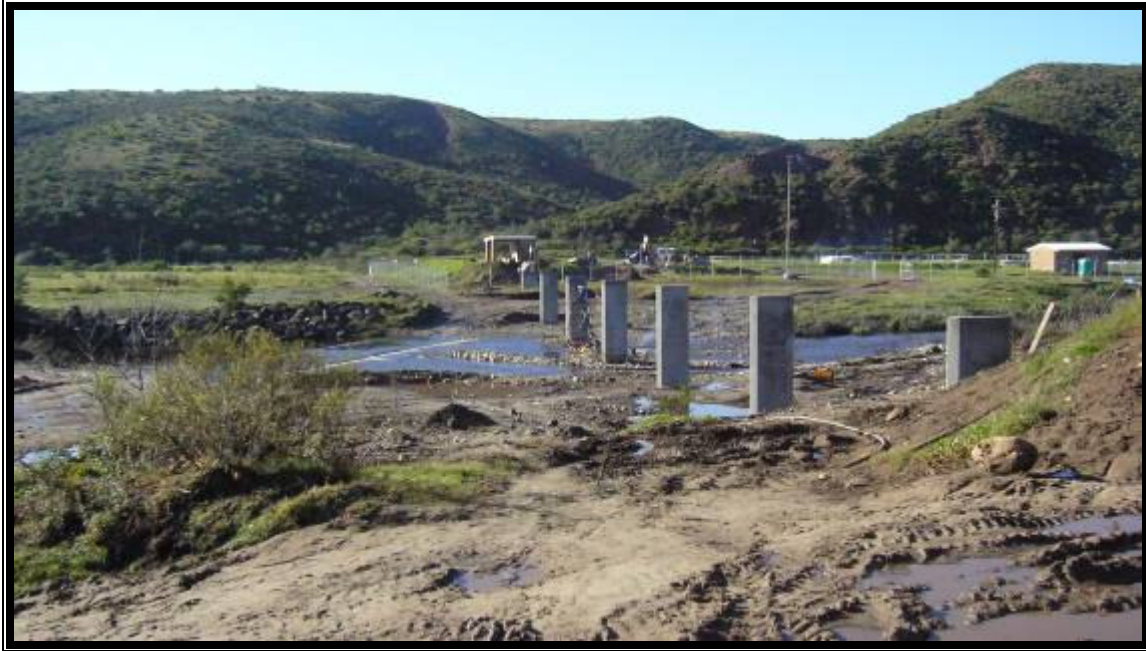
**Fig 27:** The reconstruction of the Heidelberg sewerage works, June 2005. The concrete pillars across the river are to carry the sewage pipeline from the Heidelberg side of the Duiwenhoks River to the opposite bank where the sewerage works are situated.

At present the repairs to the sewage works are still underway, while the sewage in the temporary dams is being treated with chlorine and pumped into the Duiwenhoks River further downstream. The current location of the sewage works presents a high risk to those living downstream and to the ecology of the river itself. This situation is highly problematic, posing health risks to those downstream and negative impacts on the ecology of the river itself. This is not sustainable, particularly if these flood events are to become a more common feature of this region due to possible climate change in the form and increase in the frequency and severity of the cut-off low systems responsible for floods of this nature.
