1. Common problems with donated wheelchairs

2. Key elements of appropriate wheelchairs

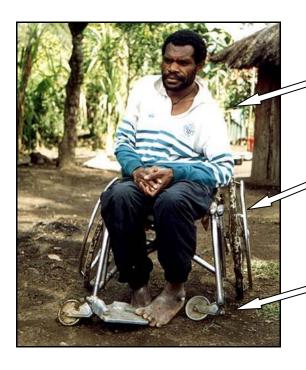
Broken upholstery and lack of postural support is causing scoliosis and other spinal problems.

Wheels no longer have tyres due to pushing the chair in rough conditions. Tyres and other replacement parts are not available locally.

Front caster forks and foot plate have broken due to inappropriate design and rough conditions and cannot be replaced locally.

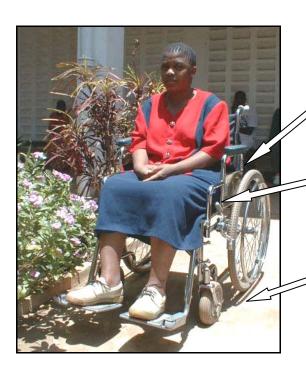
Positioning of wheels and armrests makes the wheelchair very difficult to push independently.

Lack of a pressure relieving seat cushion may cause pressure sores or other serious health problems.

Short wheelbase makes the chair unstable and pneumatic front tyres are very difficult to repair or replace.

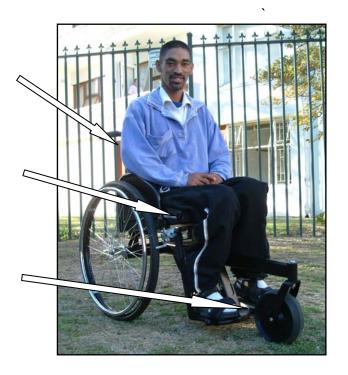
Frame fits well to provide support without restricting movement so he can push the chair independently. Adaptations were made to suit his disability and body measurements.

Pressure relieving cushion provided to protect the user's skin and prevent pressure sores.

Durable and replaceable front wheel, bearings and caster forks attached to a three wheel frame with a long wheelbase specially designed for uneven terrain.

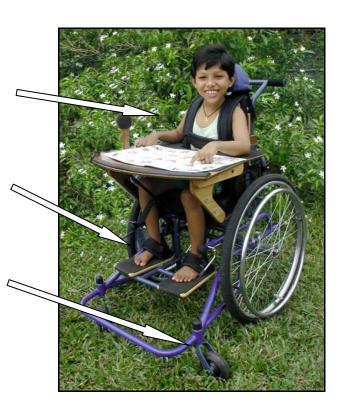
Supportive seating, designed for the measurements and needs of the user, provides greater support and frees the arms for other tasks such as pushing the wheelchair.

Footplate provides support and protection for the child's feet and legs.

Parts such as wheels, bearings and tyres are easily repaired or replaced locally.
